BY DOUG HORGAN

Rebuilding a Leaky Chimney From the Roofline Up

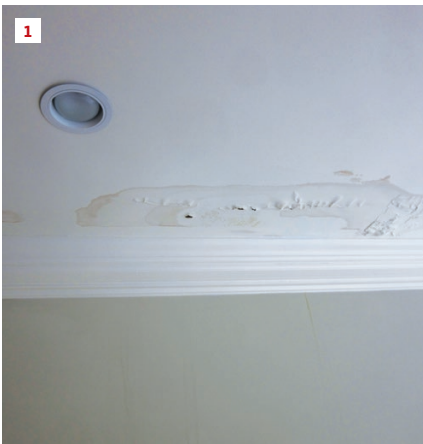
Water damage is evident on a ceiling above a second-floor fireplace (1). Infrared imaging confirms that the area is wet after rainstorms (2).

Early in the design process of a renovation project on a client's recently purchased home, we noticed some ceiling damage above a fireplace on the upper level (1). Infrared and moisture-meter measurements confirmed the area was wet after rainstorms (2), and a look in the attic showed that the masonry chimney for the fireplace was the source of the leak, with wet block and water dripping down onto the ceiling (3).

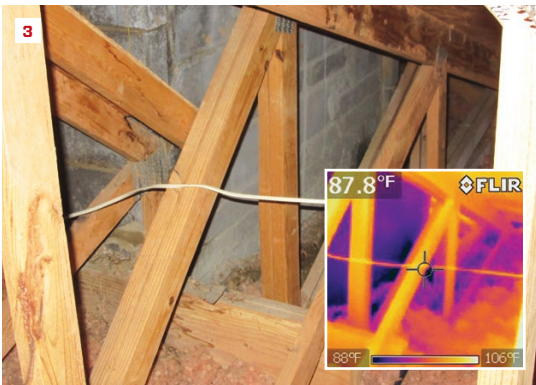
In the attic above the damage, IR imaging (inset) shows wet chimney block (3). An M & J trade partner inspects the chimney's base; roofing cement covers its shingle-to-flashing juncture (4, 5).

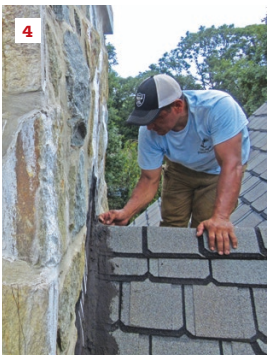
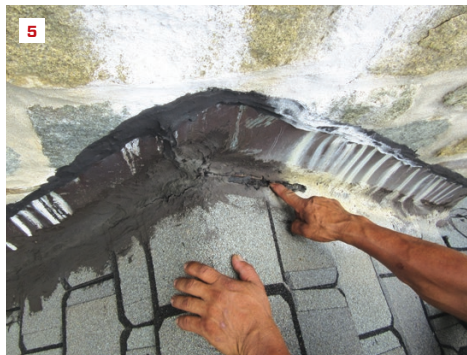
We brought in M & J Contractors from Sterling, Va., roofers who are experienced with complicated repairs. On the roof, we immediately noticed a large smear of roofing cement at the base of the chimney, obviously a previous attempt at repair (4, 5), as well as four different colors of caulking on the flashings, on mortar joints, and on the cracked crown of the chimney. When it's obvious that multiple repairs have been made, that can indicate the real problem is difficult or expensive to fix (6-10).

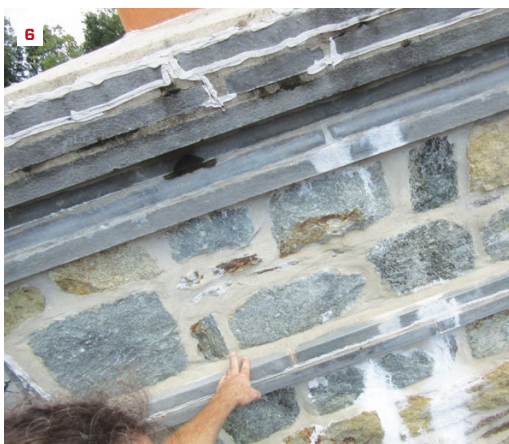
We also saw a lot of efflorescence—white, powdery residue—on the outside of the masonry. Efflorescence results from minerals, mainly calcium from the mortar, being dissolved and washed out of the masonry by water traveling through the structure. Once the water comes out, it evaporates and leaves the minerals behind. This was another clue about the problem—there was a lot of water moving within the chimney (6).

Efflorescence-stained stone veneer indicates that a lot of water had moved within the masonry chimney (6). The base flashings along the back, sides (7), and front are nailed to the face of the stone (the peeled-back caulk reveals a nail head) (8).

However, this chimney was in bad condition from the roofline up. The large amount of efflorescence and failed attempts at stopping leaks over the years led us to recommend a more certain solution: installation of a through-flashing at the roofline, waterproofing up and over the chimney core, and a rebuild of the masonry veneer.

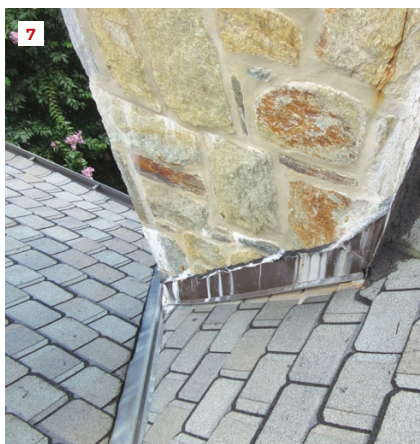
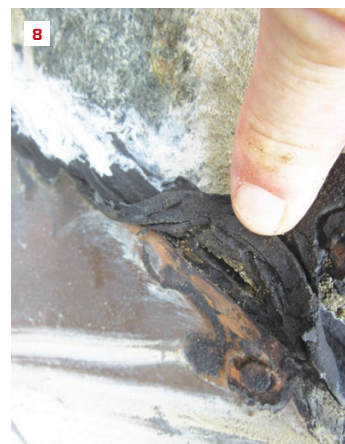
Inspecting the base flashing, we discovered it was nailed to the face of the stone (7, 8). With all the layers of caulking, it didn't appear to be leaking, but unlike a through-flashing run into the masonry, a face-applied flashing can't stop water within the masonry from traveling down below the roof level. Though many chimneys allow some water to soak down through the roof level in heavy rains, as long as there isn't much of it, this water can slowly dry out without causing any issues.

On this chimney, however, enough water was running through that it was wetting things that need to stay dry. The original masons had used a steel angle a course below the roofline to corbel the chimney out to hold the stone veneer above. This angle caught any water in the outer 4 inches of the chimney and pushed it out onto the primary bedroom ceiling, where we originally saw the water damage.

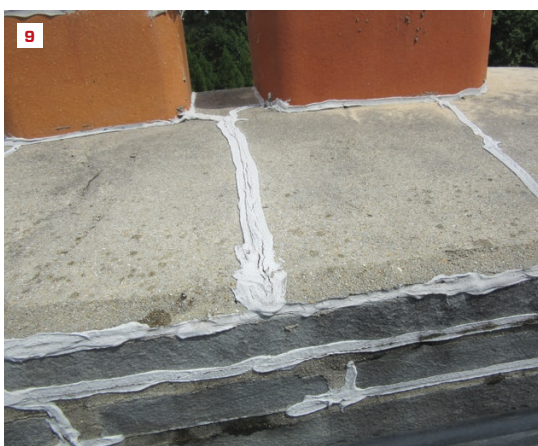
The chimney's concrete cap (9) and corbeled 1-inch-thick bluestone top are heavily caulked in an attempt to keep out moisture (10). After assembling an impressive scaffolding anchored to the building at multiple levels to provide lateral strength, the masons begin to remove the stone veneer and the cracked crown on the chimney (11).

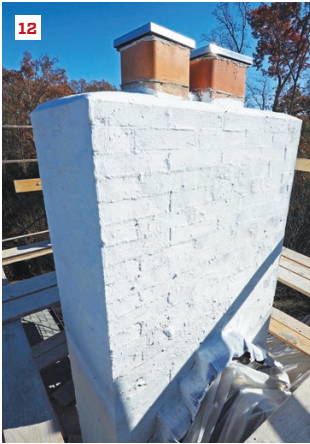
A waterproof cement-based coating (MasterSeal 581) is applied up and over the block chimney core (12). The stepped, 16-ounce copper through-flashings are fabricated and soldered on site (13). The large pieces are tacked in place with masonry anchors, and the edges sealed with polyurethane caulk (14).

Chimney repair. Working from scaffolding, the masons, Stone-work by Santo, removed the stone veneer and the cracked crown from the chimney (11). Minor repairs were done to the first course of block at the roofline to make even steps for the through-flashings. A liquid-applied masonry waterproofing (MasterSeal 581, formerly Thoro-seal)—designed to fill holes and small voids, work on dirty, existing masonry, and make a uniform coating without seams, unlike sheet materials—was brushed onto the block to seal the chimney core (12).

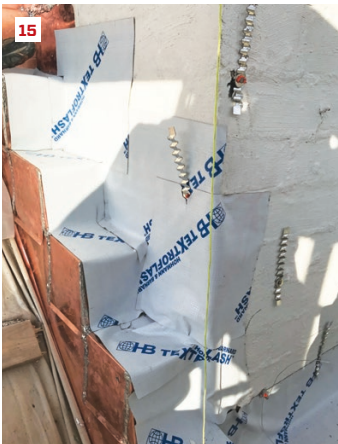
Textroflash peel-and-stick through-flashing is applied to the cured cement-based waterproofing on the chimney core and lapped onto the copper step flashing (15). The stone veneer is reapplied, building the chimney out to its original 44-by-66-inch dimension (16). A new chimney cap was later installed by the mason.

ing it to the cured waterproofing on the chimney's block core and lapping it onto the copper step flashing. Santo's crew prefer to add this layer to protect the metal from their work and from the caustic masonry over time (15). The veneer was reapplied to the top of the chimney (16), and a new cap placed at the top.
