# Understanding Frost Free Hose Bibs

By Mark Townsend – Home Inspector/Owner - T2 Home Services

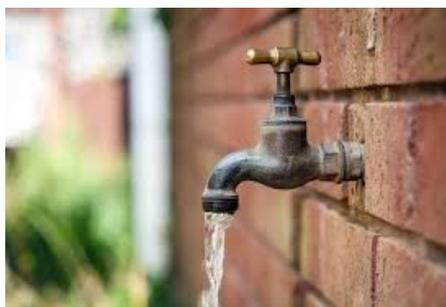
An Exterior Hose Bib, or otherwise called a Sill Cock, is a “[Tap](#)” point to the homes water supply. It is commonly used to connect a garden hose for various uses on the exterior of the home such as watering the lawn or washing the car.

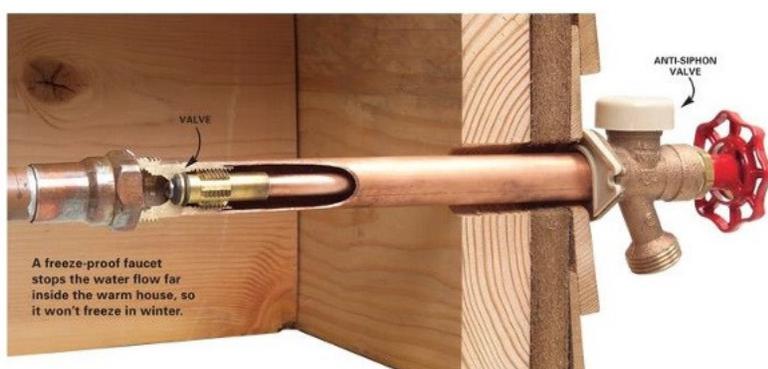
In 1965, a patent was filed by [Nibco Inc.](#), for a “Frost Free” type of hose bib where the shutoff point was relocated from the exterior, to a point that could be placed within the insulated space of the structure.

A tube was attached to the valve, which contains a rod attaching the control handle on the exterior, to a seal at the other end, thus stopping the water flow before it entered the cold space. These are traditionally installed in either a wall or floor cavity that can be insulated with the structure.

Let's first understand how these units are constructed. The most common frost-free hose bibs/sill cocks being sold today consist of a copper or brass tube which contains the shutoff rod and seal, along with a brass “bib” that contains the valve handle and hose connection fitting. Additionally, most units today also are fitted with a “[Anti-Siphon](#)” valve, which will be discussed in a separate article. Although the bib, or hose connection is usually made of a thick and hardened brass material that weathers well, the valve tube is not. On the majority of these units, this tube is made of a light copper or brass material that does not easily corrode and allows the rubber seal to easily move inside to provide a good seal. Since this part is designed to be inside the conditioned space, the common materials used work very well and as intended.

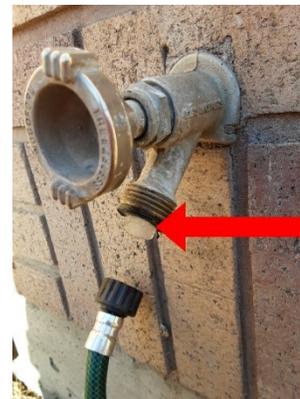
- 2) **Remove hose during freezing weather** – It is recommended by most faucet manufacturers to remove hoses, timers, etc. when not in use, but is even more important on Frost Free units and critical during freezing weather. When the hose is left attached, the faucet cannot drain the valve tube and water is trapped inside a tube that is not designed to freeze. When the water in the hose freezes, it can expand back into the valve tube section and cause it to crack as shown here.

When a frost-free bib cracks during the winter, you may not even realize it until spring. When you turn that faucet on to water the lawn, pressurized water enters the cracked valve tube, and exits into the wall or floor cavity where it is installed, leading to a possibly expensive repair.
